# Water Infiltration

Reason for inspection was to determine the location of the water leak(s) that has caused extensive damage in the lower level of the home.

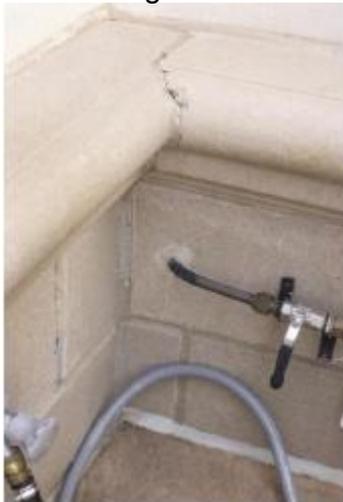
The next test was the exterior wall northwest corner. The test was to be done for 10 minutes but water was showing after only 3 minutes. The cause was cracks in the stone and the joints above the gas line next to the BBQ.

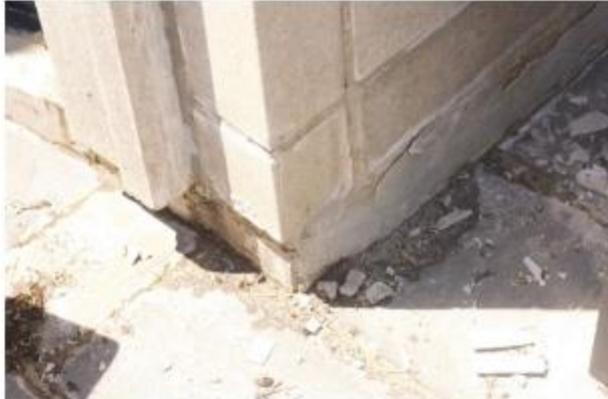
Corner outside of spare bedroom behind potted fir tree. There is flaking mortar and damaged parging.

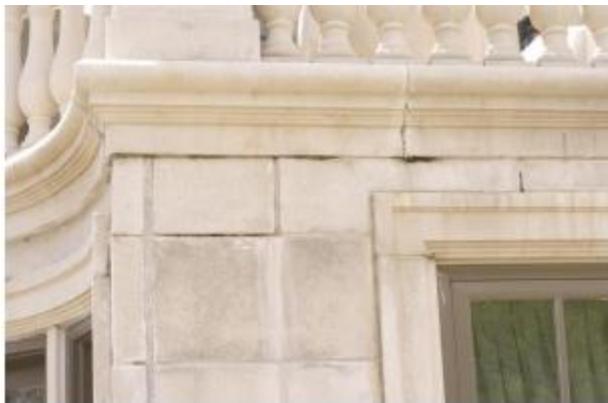
Area above the potted fir tree outside of the spare bedroom, cracks in the mortar and mortar that has become soft.

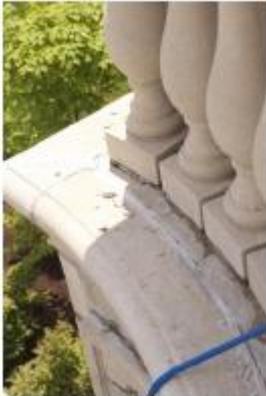
Railing and pillars above the spare bedroom. This damaged mortar is consistent with the condition of the railing the length of the patio.

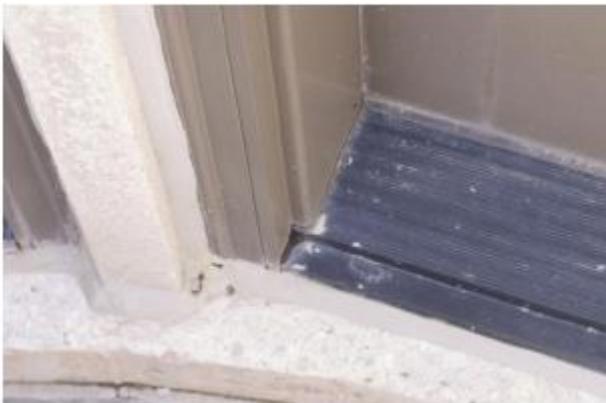
The carpeted area of the spare bedroom at the floor to ceiling windows was wet at the time of the inspection. The conditions for the growth of mold present and evident. It appears that the caulking in the lower areas of the windows has failed and needs to be addressed. This is the likely cause of the leak. There is evidence that the window on the northwest side was leaking from above but a repair has been made in that past there was no evidence that it is still leaking.

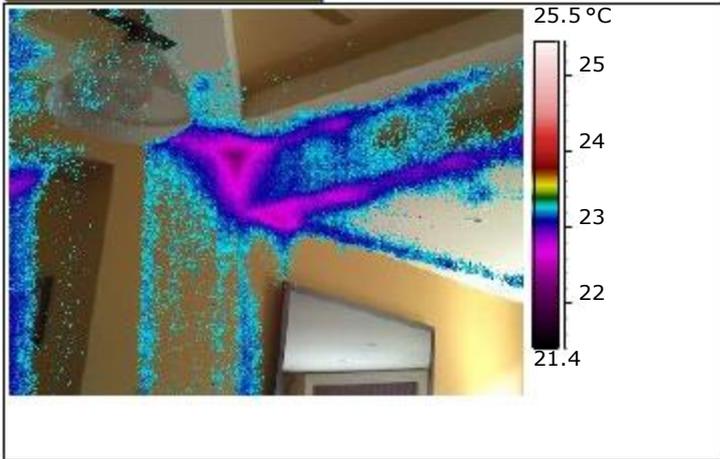
**Thermogram 30/05/2013**

This image was taken before the testing was done. The blue and pink areas are not moisture. They are temperature difference in the steel beam in the wall. There was no moisture present at this time.
