Thermal Imaging Inspection

Expressway Span

By Thermal Images.ca London Ontario

12/3/2012

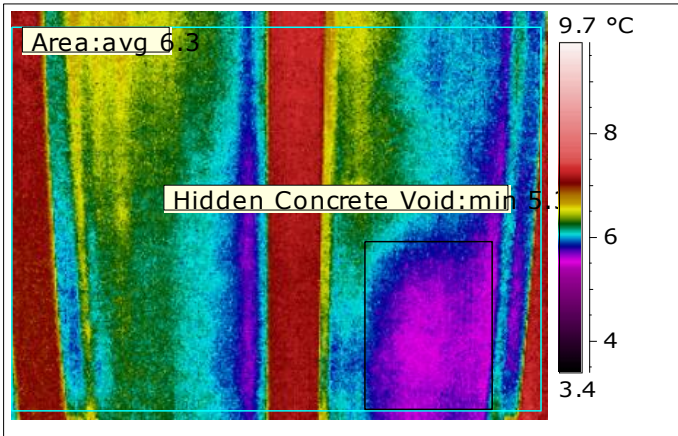
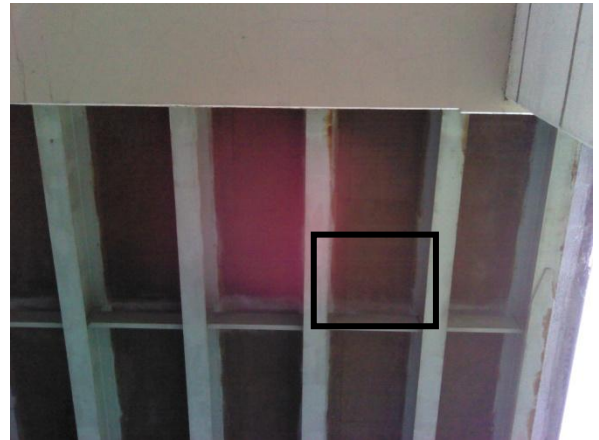
Image Time	12:37:34 AM	Location:	Span
Emissivity	0.95	Other remarks:	
Object Distance	12.0 m		
Atmospheric Temperature	8.7 °C		
Reflected Temperature	7.4 °C		
Ar2 Average Temperature	6.3 °C		
Hidden Concrete Void Min. Temperature	5.3 °C		
File name	IR_1633.jpg

Comment: Void in concrete. Under east bound lanes. Second row of girders. First section from adjacent Bent

Recommendation: Concern level HIGH

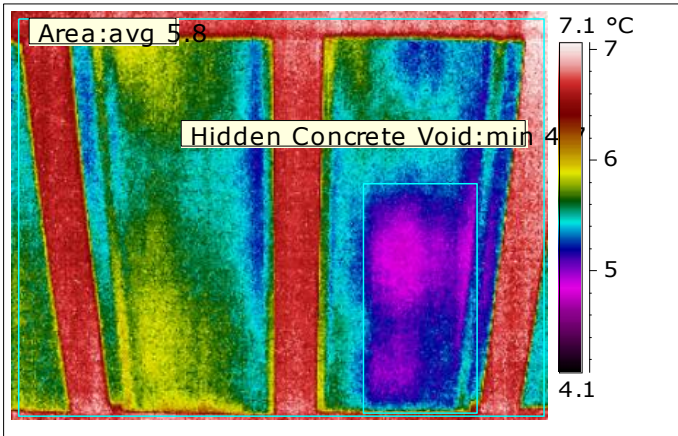
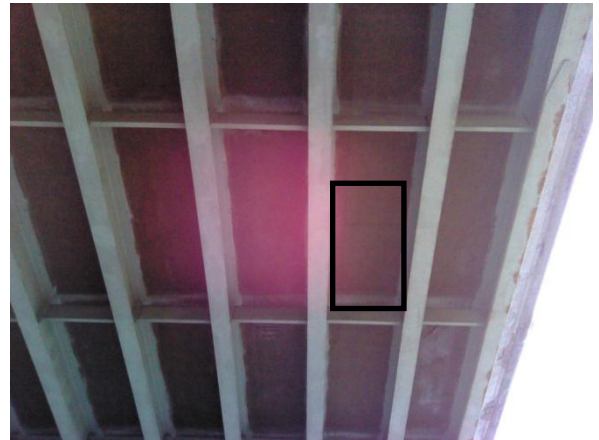
Image Time	12:37:54 AM	Location:	Span
Emissivity	0.95	Other remarks:	
Object Distance	12.0 m		
Reflected Apparent Temperature	15.0 °C		
Atmospheric Temperature	8.7 °C		
Ar2 Average Temperature	5.8 °C		
Hidden Concrete Void Min. Temperature	4.7 °C

Comment: Void in concrete. Under east bound lanes. Second row of girders. Second section from adjacent Bent

Recommendation: Concern Level HIGH

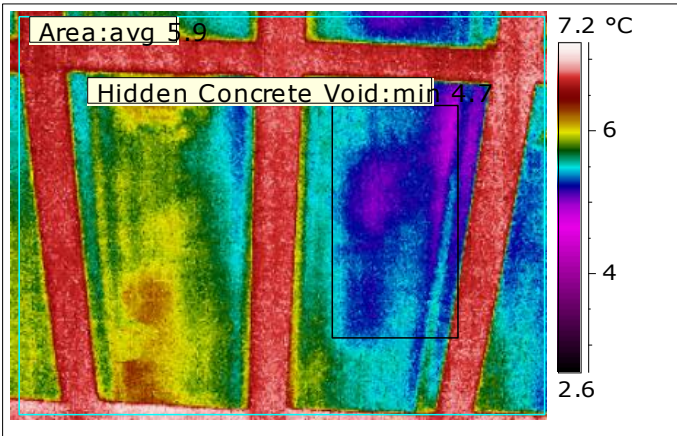
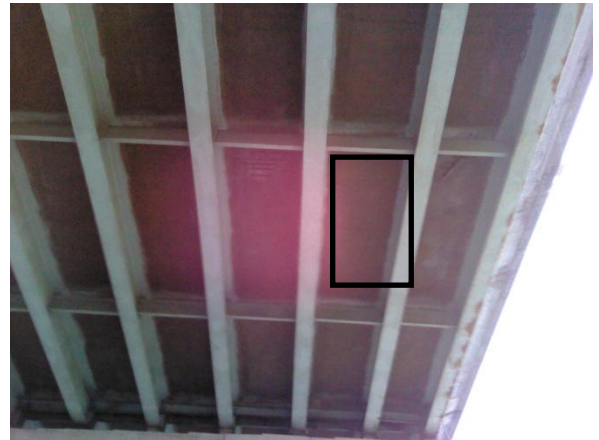
Image Time	12:38:19 AM	Location:	Span
Emissivity	0.95	Other remarks:	
Object Distance	12.0 m		
Reflected Apparent Temperature	15.1 °C		
Atmospheric Temperature	8.7 °C		
Area Max. Temperature	7.2 °C		
Hidden Concrete Void Max. Temperature	6.9 °C		
File name	IR_1637.jpg

Comment: Void in concrete. Under east bound lanes. Second row of girders. Second section from adjacent Bent

Recommendation: Concern Level HIGH

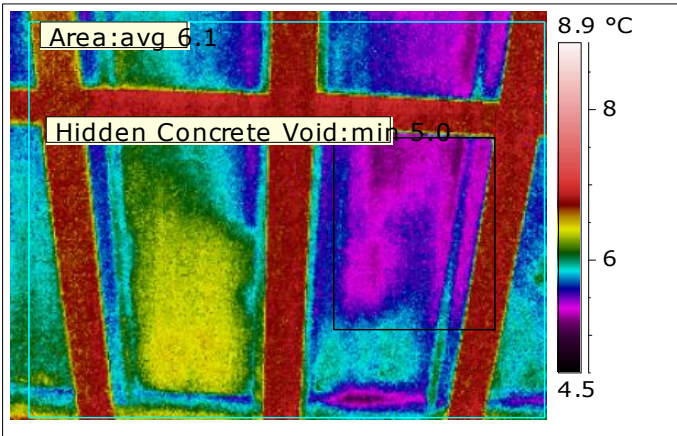
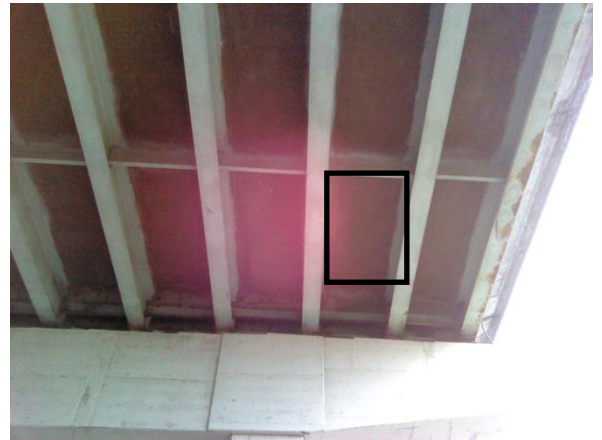
Image Time	12:38:46 AM	Location: Span
Emissivity	0.95	Other remarks:
Object Distance	12.0 m	
Reflected Apparent Temperature	15.1 °C	
Atmospheric Temperature	8.7 °C	
File name	IR_1639.jpg	
Ar2 Average Temperature	6.1 °C	
Hidden Concrete Void Min. Temperature	5.0 °C

Comment: Void in concrete. Under east bound lanes. Second row of girders. First section from adjacent Bent

Recommendation: Concern level HIGH
