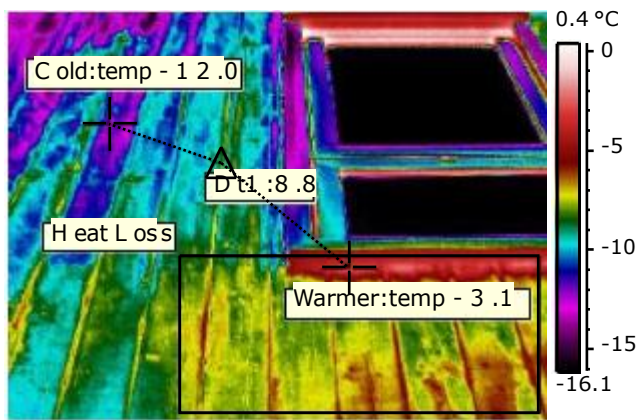
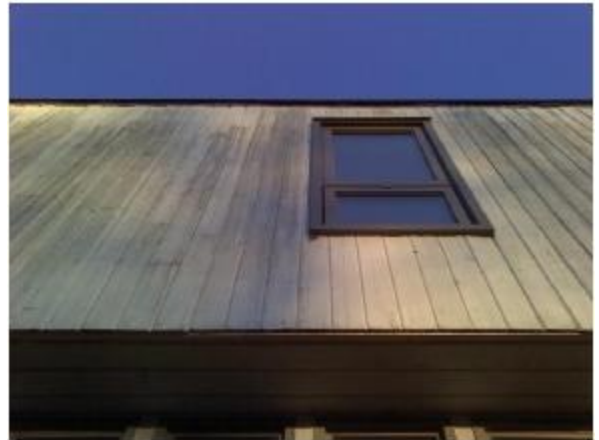
Date	08/12/2011	Name:	
Image Time	8:24:35 AM	Address:	
Image Camera Type	FLIR T300	<b>Other remarks:</b>	
Emissivity	0.90		
Object Distance	5.0 m		
Reflected Apparent Temperature	20.0 °C		
Atmospheric Temperature	10.0 °C		
Heat Loss Max. Temperature	-2.2 °C		
Sp1 Temperature	-12.0 °C		
Sp2 Temperature	-3.1 °C

**Comment:** The leak around the window has caused the insulation in the wall to be saturated causing heat loss and the potential for mold growth. There is a 9. C temperature difference between the bottom of the window and the area to south of the window.

**Recommendation:** Have any wet insulation and drywall around the window replaced.

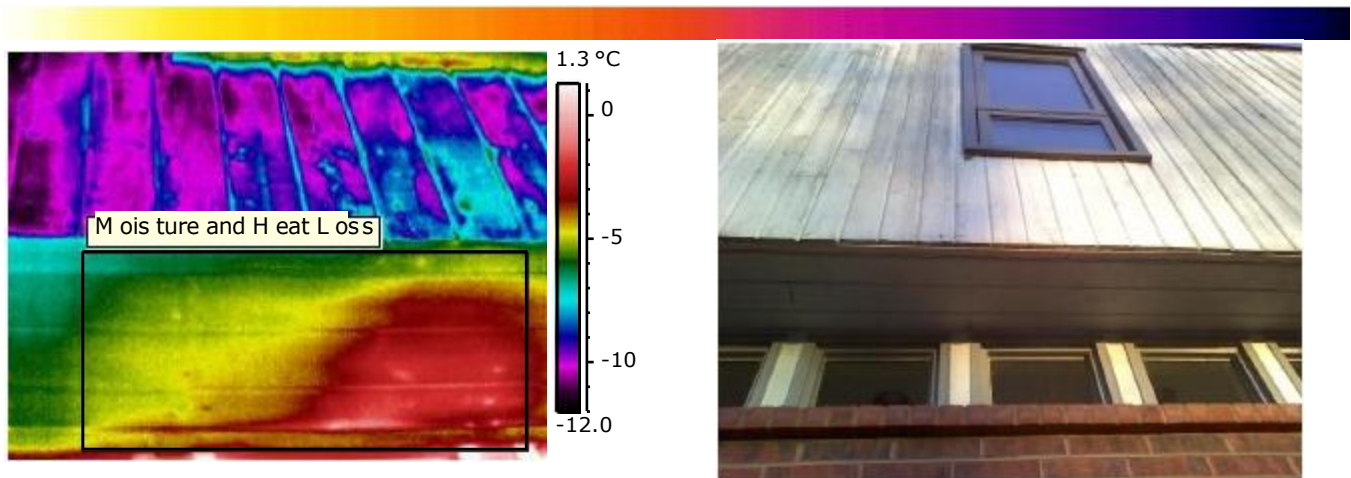
Date	08/12/2011	Name:	
Image Time	8:25:18 AM	Address:	
Image Camera Type	FLIR T300	<b>Other remarks:</b>	
Emissivity	0.86		
Object Distance	4.0 m		
Reflected Apparent Temperature	20.0 °C		
Atmospheric Temperature	-1.0 °C		
Ar1 Max. Temperature	2.9 °C

**Comment: Moisture and heat loss are evident here. The removal of the insulation in the floor cavity is causing the heat loss. The moisture is from the leak around the window.**

**Recommendation: After the floor cavity has been dried out and its structural soundness has been assessed, reinstall new insulation.**

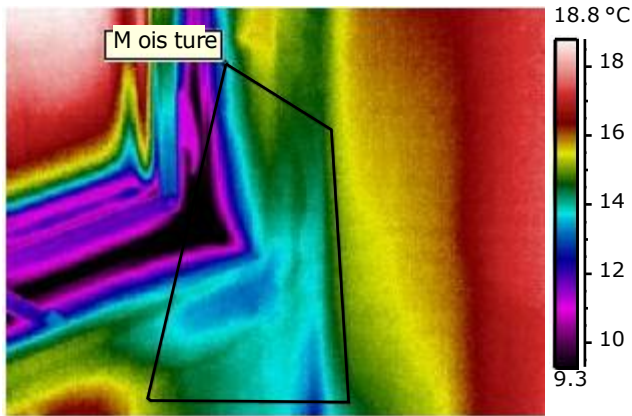
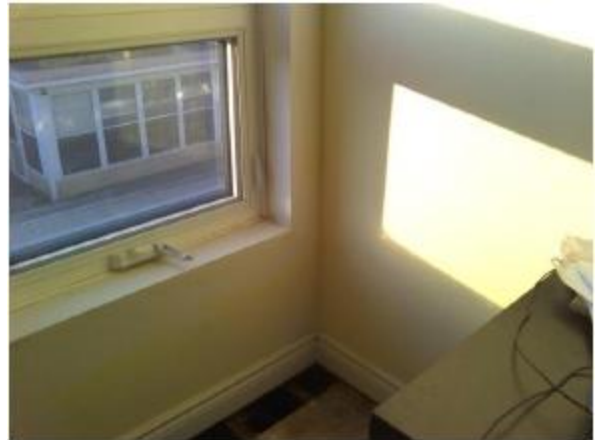
Date	08/12/2011	Name:	
Image Time	8:36:03 AM	Address:	
Image Camera Type	FLIR T300	<b>Other remarks:</b>	
Emissivity	0.86	<b>The moisture meter showed readings of 45% in the sill area and bellow. The readings dropped to 19% about 24 inches above the sill.</b>	
Object Distance	1.0 m		
Reflected Apparent Temperature	20.0 °C		
Atmospheric Temperature	23.0 °C		
Ar1 Max. Temperature	15.6 °C

**Comment:** The thermal image shows the extent of moisture in the window sill. The moisture meter readings confirmed the presence of moisture in the wall.

**Recommendation:** Have a professional window installer come out and asses whether the window can be removed and reinstalled or if it should be replaced. The floor area below the window needs to be dried and assessed as to the extent of the structural damage.
